THE INSPECTED HOME 204 Alec Craig Way Gulf Harbour

Date:	7 July 2015
Inspection:	2250

- For: Marion Sheldon P O Box 14274 Tauranga
- Inspect: 204 Alec Craig Way Gulf Harbour

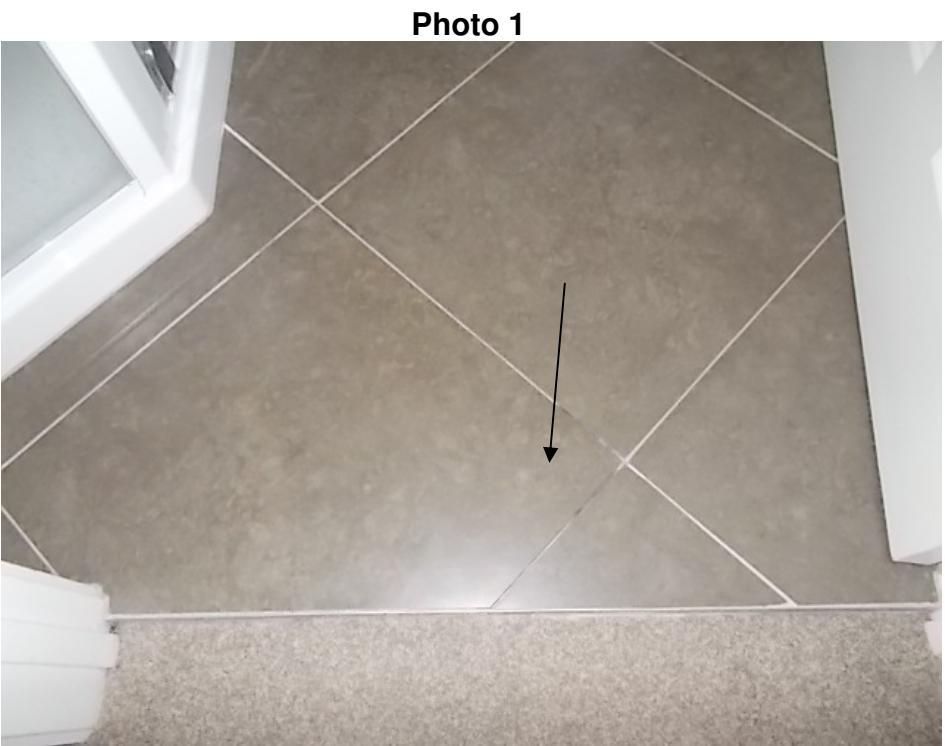
- Ceramic floor tiles with an obscured glass window providing natural light.
- Note: one of the tiles directly upon entering the bathroom is showing some movement when applying pressure and loss of tile grouting (refer photo 1), which means is may crack at some stage.
- Corner shower cubicle with glass enclosure, hinged glass door and good water pressure noted.
- Bath.
- Single bowl vanity unit.
- Dual flush toilet.
- Heated towel rail.
- Combination heat lamp and mechanical extraction.
- An underfloor heating temperature control panel/thermostat is wall mounted.
- 240v power point.

One of the tiles directly upon entering the bathroom is showing some movement when applying pressure and loss of tile grouting.

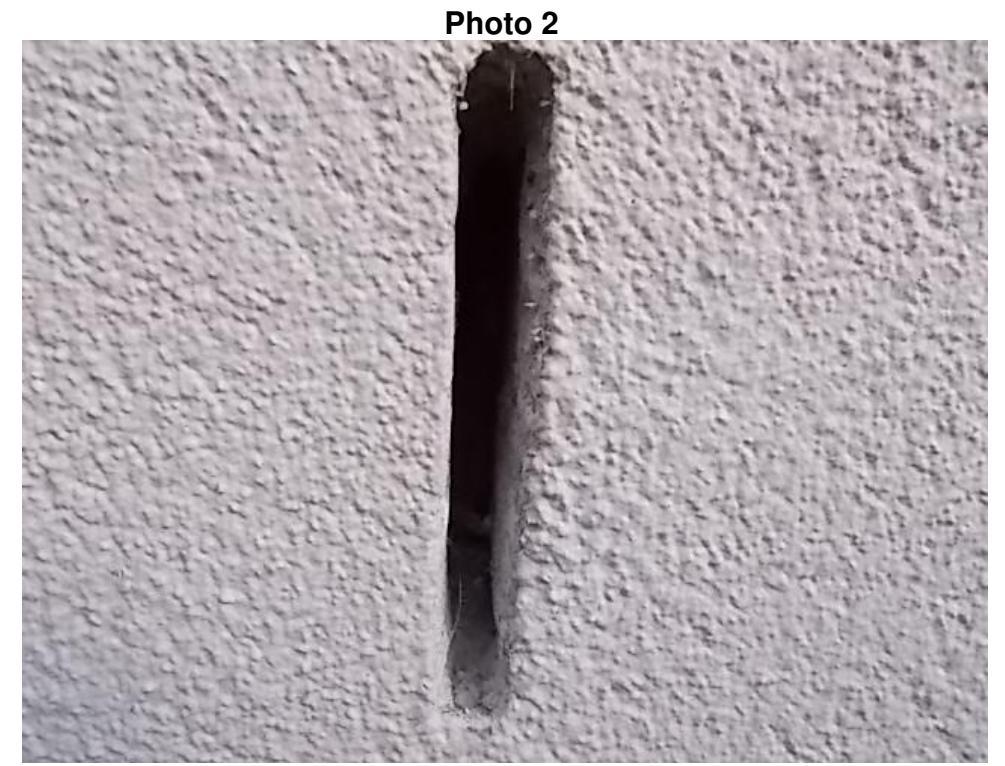
Note: a number of the drainage slots at the base of the rendered brick cladding have not been properly cleared, with sand and cement mortar sighted inside these slots (refer photo as an example). These slots are designed to drain any water which may enter the brick cavity, and also provide ventilation in order to dry the cavity after rainfall. Clearing the slots would be recommended at some stage even though no issues were noted as a result. Also noted was the lack of drainage slots at both the north-east and north-westerly corners of the building (refer photos 3-4), which is very unusual and appears to be an oversight. Adding drainage slots here would also be recommended, as this is a requirement under current Building Code Regulations even though no issues were noted as a result.

- 1. A number of the drainage slots at the base of the rendered brick cladding have not been properly cleared, with sand and cement mortar sighted inside these slots (refer photo 2 as an example). These slots are designed to drain any water which may enter the brick cavity, and also provide ventilation in order to dry the cavity after rainfall. Clearing the slots would be recommended at some stage even though no issues were noted as a result. Also noted was the lack of drainage slots at both the north-east and north-westerly corners of the building (refer photos 3-4), which is very unusual and appears to be an oversight. Adding drainage slots here would also be recommended, as this is a requirement under current Building Code Regulations even though no issues were noted as a result.

A number of the drainage slots at the base of the rendered brick cladding have not been properly cleared, with sand and cement mortar sighted inside these slots.

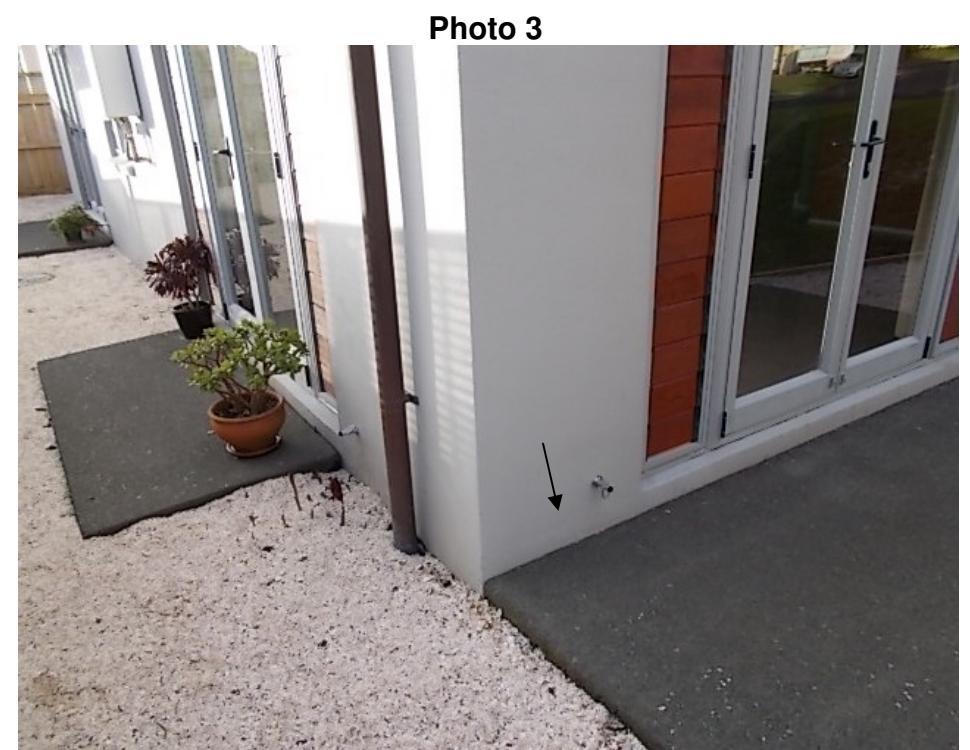
Lack of drainage slots at both the north-east and north-westerly corners of the building.

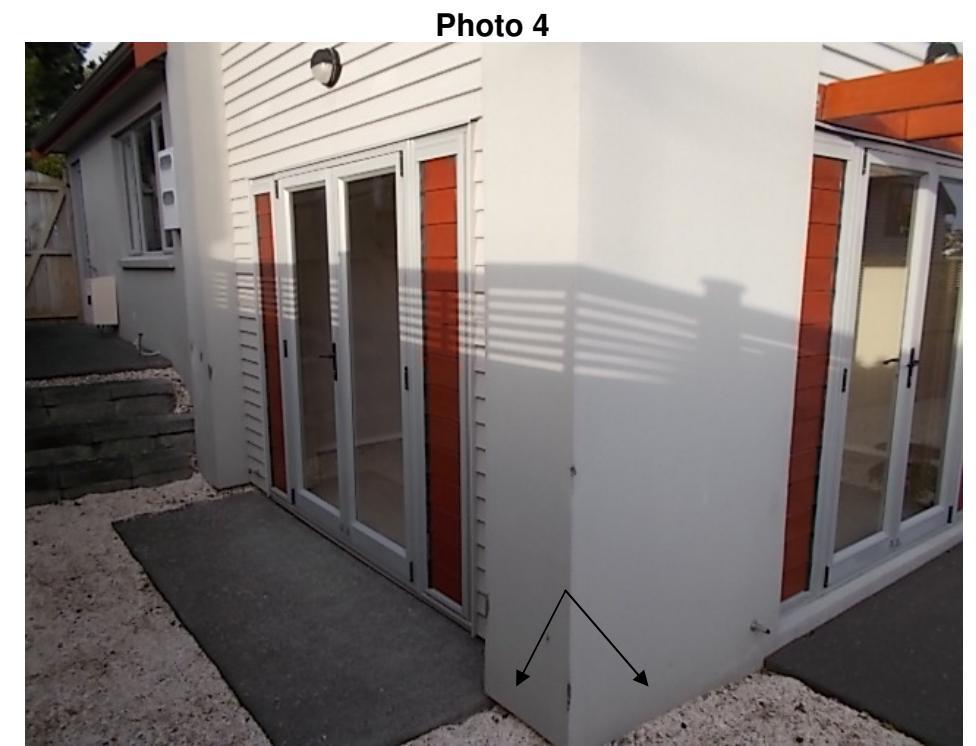
Lack of drainage slots at both the north-east and north-westerly corners of the building.

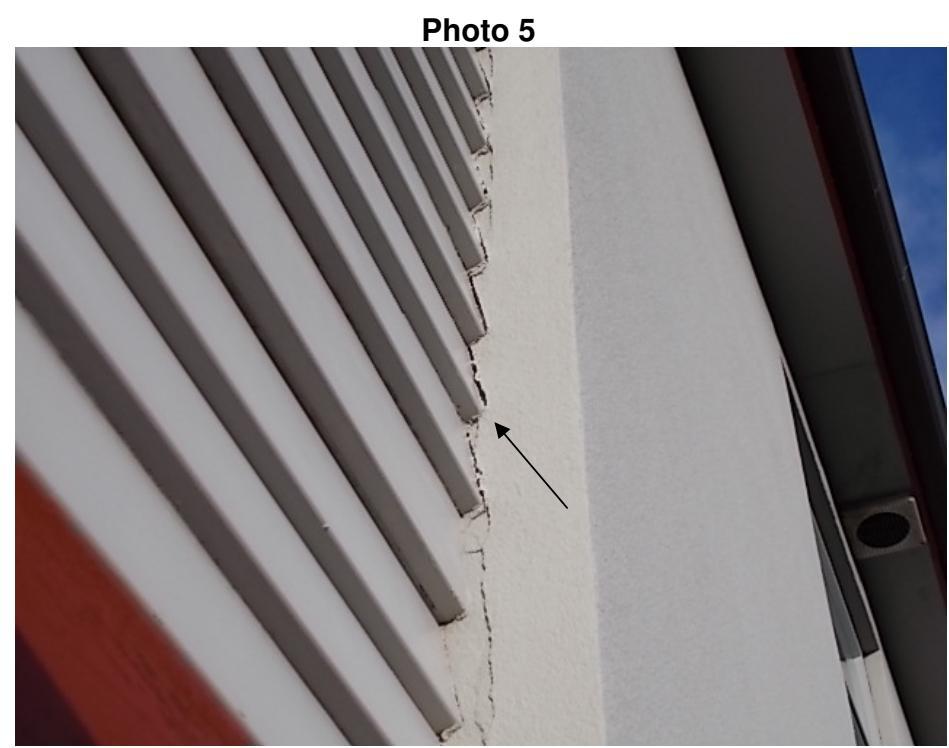
Gaps can be seen opening between the plastered brick and weatherboard cladding at the rear of the dwelling.

Note: gaps can be seen opening between the plastered brick and weatherboard cladding at the rear of the dwelling (refer photo 5 as an example). It is recommended that these gaps be properly cleaned and prepped so that they can be resealed with a good quality paintable silicone sealant in order to prevent driving rain from being able to enter.

- 2. Gaps can be seen opening between the plastered brick and weatherboard cladding at the rear of the dwelling (refer photo 5 as an example). It is recommended that these gaps be properly cleaned and prepped so that they can be resealed with a good quality paintable silicone sealant in order to prevent driving rain from being able to enter.
